## ***The Challenge of Safe Return of the Space Shuttle to Flight***

N. Wayne Hale, Jr.  
Space Shuttle Program  
Deputy Manager

# Program Management Challenges to the Safe Return of the Space Shuttle to Flight

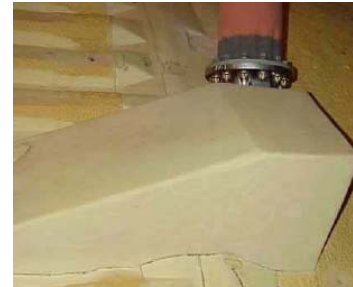
Bipod Foam Ramp

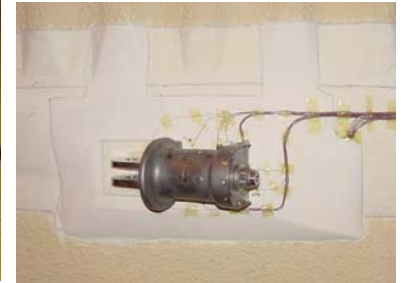
Redesigned Bipod Fitting

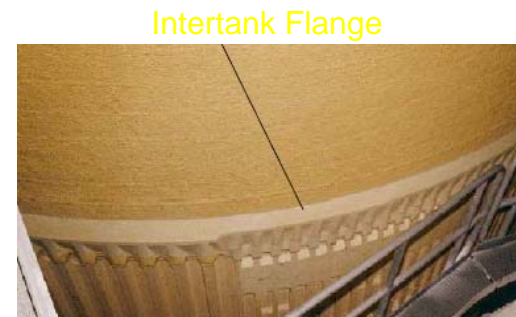
Intertank Flange

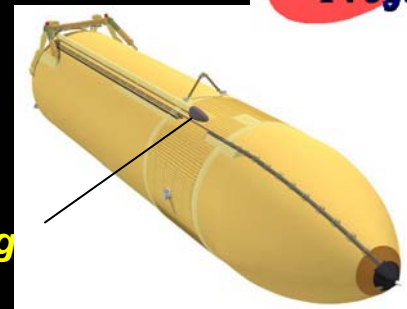
- Critical debris zone previously identified as  $\pm 67.5^\circ$  from Z axis, Orbiter side of tank

*Feedline Fairing (reference)*

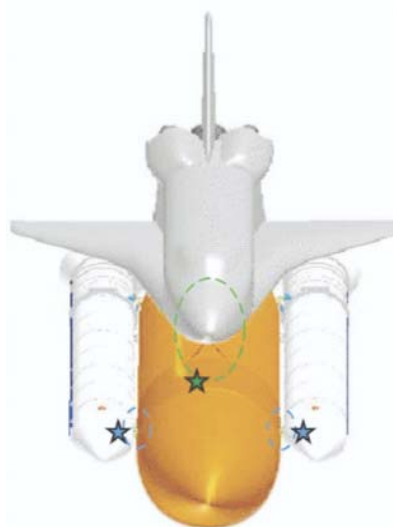
Proposed STS-114  
Camera Locations

SRB Mounted Camera

ET Mounted Camera

- Detection on ascent improved by using integrated approach
- Additional Ground-Based trackers added and all upgraded
- Aircraft and ship-based support under consideration
- Digital cameras on External Tank, Solid Rocket Booster, and Orbiter improve real-time assessment
- Handheld crew cameras support added systems

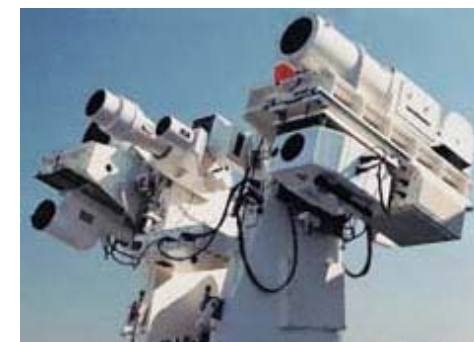
Ground Tracking

Short, Medium and Long-Range Trackers

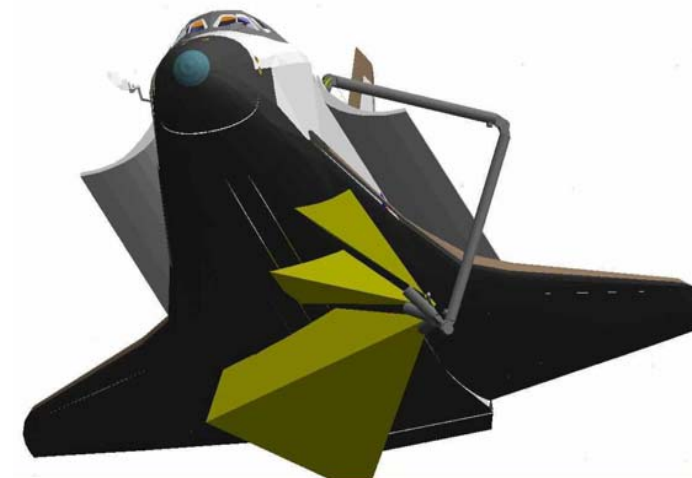
**Boom Installed on Starboard Sill**

- New boom for Shuttle system for TPS inspection
- Attaches to the existing Shuttle's robotic arm
- Boom mounted television/laser sensors
- System compliments other RTF initiatives to understand TPS condition post-launch
- Boom system currently on critical path

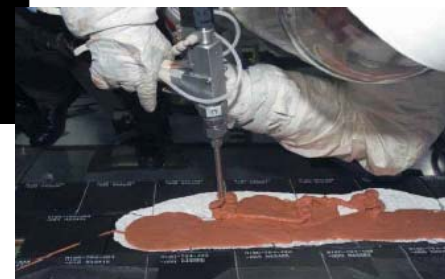
- Various approaches being considered
- Tile repair concept well-defined; cure in-place ablator (CIPA) and application tools in development
- RCC repair tools still in conceptual phase
- First flight to demonstrate TPS repair capabilities

Wrap Concept

Fabric or Metallic Overwrap

Plug Concept

Fill Concept

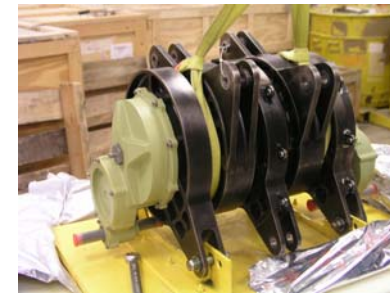
Rudder Speed Brake Actuator

- Since the Body Flap actuators and Rudder Speed Brake (RSB) actuators were fleet leaders (most flight time), decision was made to also remove the RSB actuators and inspect for corrosion
  - All 4 RSB actuators appeared to have corrosion and were sent to the vendor for further inspection and refurbishment as required

- Decision was made to install the spare RSB actuators while the other units were undergoing vendor inspection
  - Issue was raised about whether the grease in the spares had degraded and might pose a threat if re-installed – independent analysis initiated
- While the RSB actuators were undergoing vendor inspection, one of the actuators was found to have an improperly installed planetary gear

*Result: The improperly installed planetary gear led to a decision to look at the RSB actuators in all three vehicles and determine if there were other planetary gears improperly aligned. This had a significant impact on being able to meet a fall 2004 launch date.*

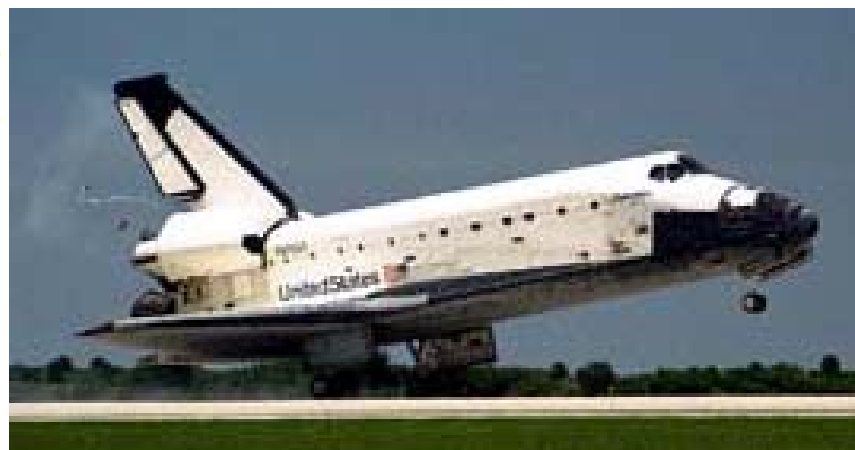
*Background:* During the OV-103/Discovery Orbiter Maintenance Down Period (Summer of 2003), Corrosion was found on the Orbiter's Body Flap actuators

RSBA #4

RSBA #3

RSBA #2

RSBA #1

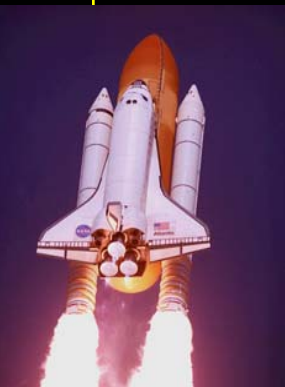
122 feet	<i>Length</i>	138 feet
78 feet	<i>Wingspan</i>	112 feet
173,500 pounds	<i>Empty (dry) weight</i>	93,680 pounds
April 12, 1981	<i>First flight</i>	B737-100 April 9, 1967 (-900 Nov 20, 1997)
To low earth orbit: 56,000 lbs (including crew of 7 & provisions)	<i>Payload</i>	52,500 pounds Crew of 2 + 189 Passengers
<b>SHUTTLE EXTERNAL TANK:</b> DRY 66,000 LBS; LOADED 1,655,600 LBS <b>SHUTTLE SRB (EACH):</b> EMPTY 192,000 LBS; LOADED 1,292,000 LBS <b>SHUTTLE SYSTEM DRY WEIGHT:</b> $173,500 + 66,000 + 192,000 + 192,000 = 623,500$ LBS <b>ORBITER ONBOARD PROPELLANT LOAD (OMS + RCS):</b> $23,876 + 7,256 = 31,091$ LBS <b>SHUTTLE SYSTEM PROP WT:</b> $1,100,000 + 1,100,000 + 1,589,600 + 31,091 = 3,821,000$ LBS	<i>Fuel</i>	6,875 US GAL = 55,000 pounds

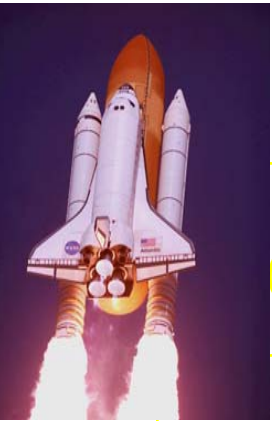
17,500 MPH (M=25 at 400,000 feet)		M 0.82
Zero payload 600 N. Miles (3,600,000 feet)		41,000 feet
Average Trip Distance 4 Million miles (14 days)		3,158 statute miles (6 hours)
6,750,000 pounds		2CFM56-7B26 engines 26,300 pounds
